Guidelines for Rehabilitating Buildings  
at the Presidio of San Francisco

*Prepared by  
Architectural Resources Group  
San Francisco, California*

*for  
Presidio Project Office, Golden Gate National Recreation Area  
Denver Service Center  
National Park Service  
U. S. Department of the Interior*

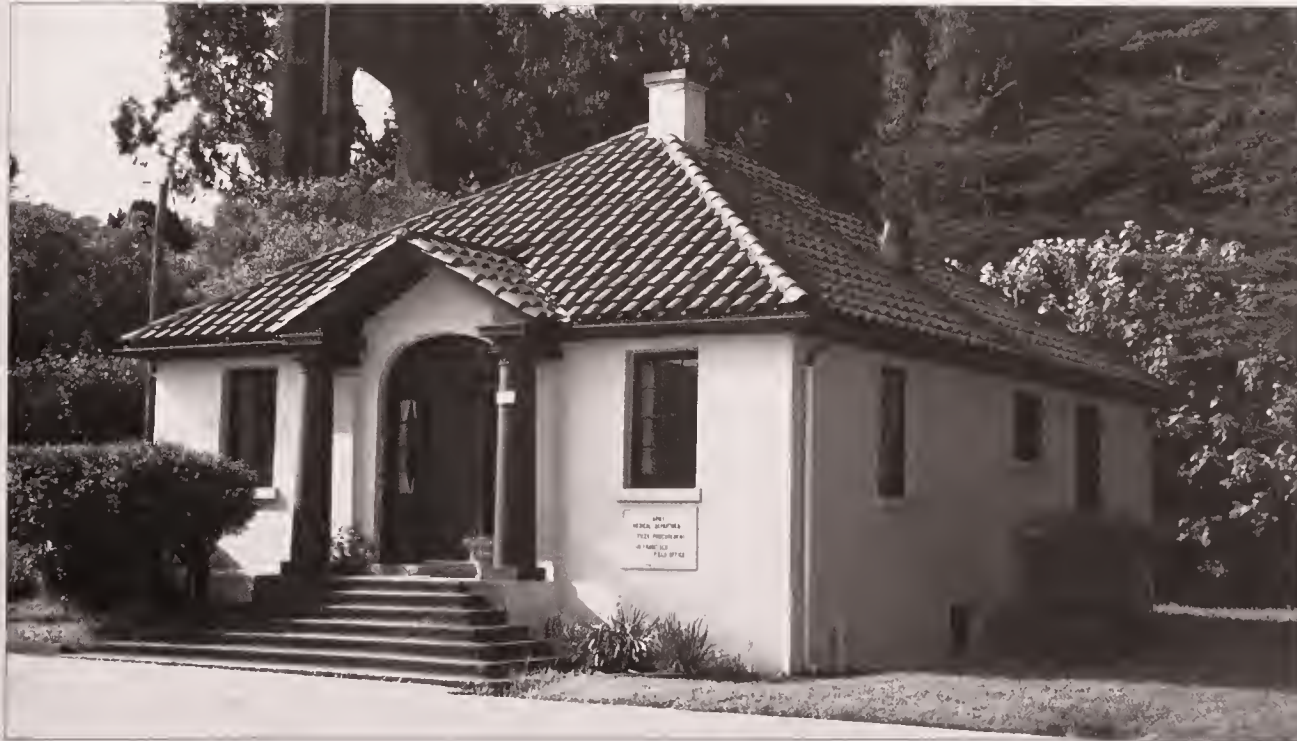
*Certain buildings have features that should not be altered; this building's historically significant entrance, together with its confined site bounded by roadways, may preclude modification for the disabled. In this case, a wheelchair lift at a secondary entrance is a possible alternative.*

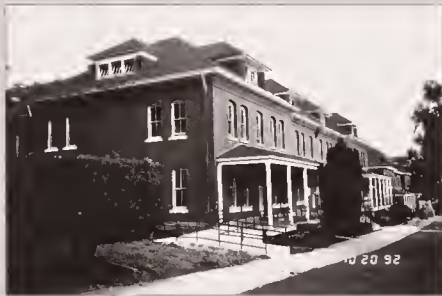
*The successful modification of a frequently used Presidio building is shown above. The lawn was regraded to minimize the visual impact of the ramp, and a simple, complementary pipe railing was installed.*

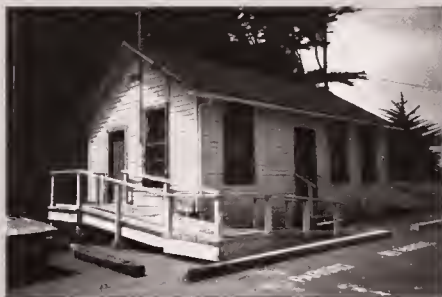
*This ramp, while stylistically neutral, overpowers the modest building. It is also too steep and has a noncompliant railing.*

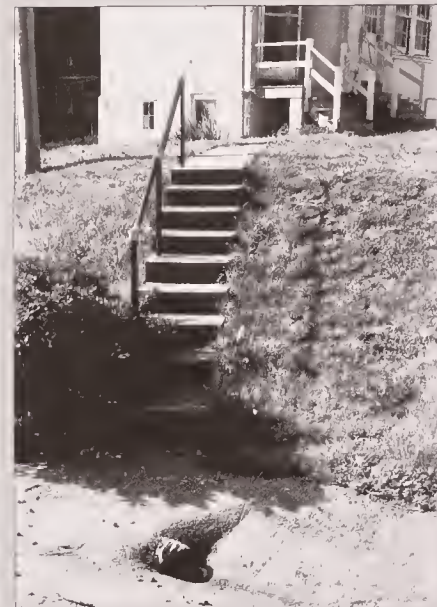
*The Presidio presents many obstacles to access for the disabled, some due to topography and others due to poor planning and design, as shown here by the unpaved path and exposed drainage culvert.*

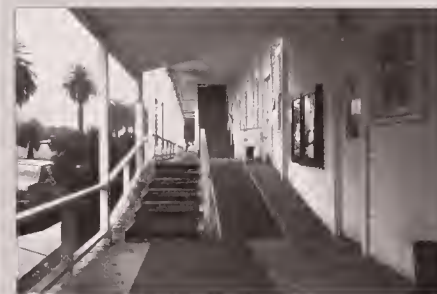
*Only a small number of Presidio buildings have been modified to ensure accessibility. In most cases, as shown above, the solutions do not comply with codes because of slope, railing design, or incomplete access, or the damage to the building's significant historic features.*

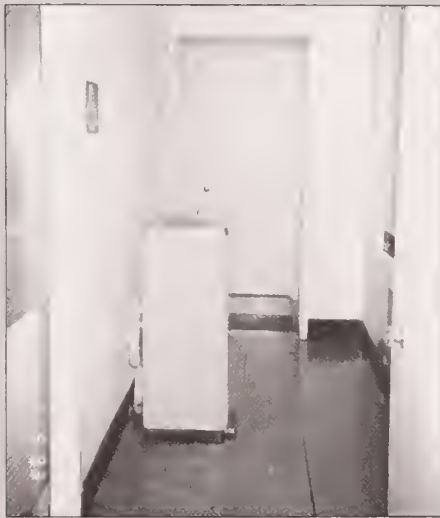
Here, both a drinking fountain and a change of floor level at the door prevent an un-obstructed path of travel for the disabled.

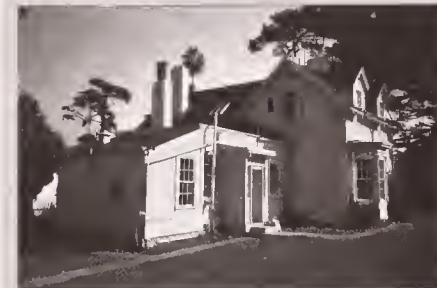
*This residence, though one of the oldest at the Presidio, has features that allow it to be adapted for disabled use—a near grade level entrance, appropriate space for a bedroom and bath on the first floor, and doors and halls of adequate width.*

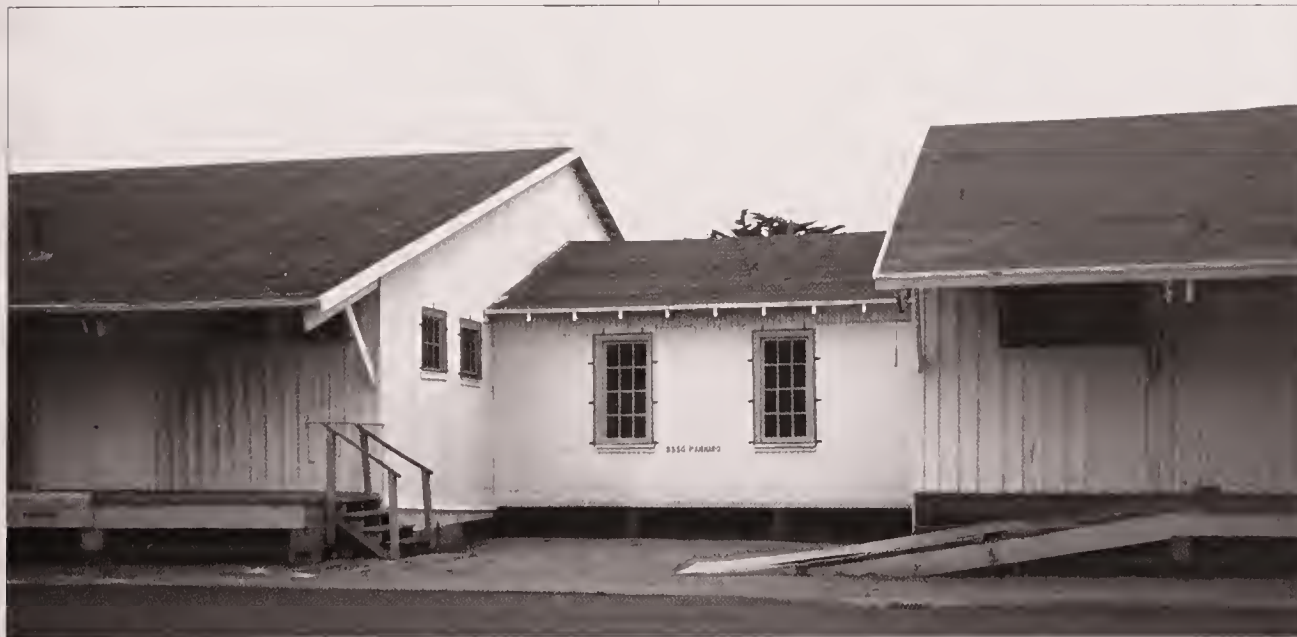
*Some utilitarian buildings, such as these warehouses, are equipped with ramps for moving materials. These are not compliant with accessibility standards, but are historic features. New, compliant ramps must be added without destroying the historic character of the building. Where several warehouses are connected by a continuous loading dock, a single compliant ramp may provide access to the entire group.*

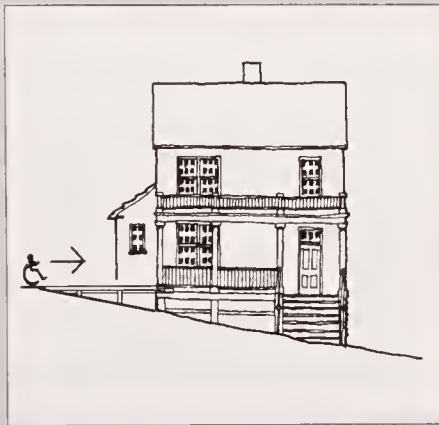
*Some buildings at the Presidio, such as this residence, have no disabled access to their front doors. The porch may be extended to meet existing grade, using compatible building materials.*

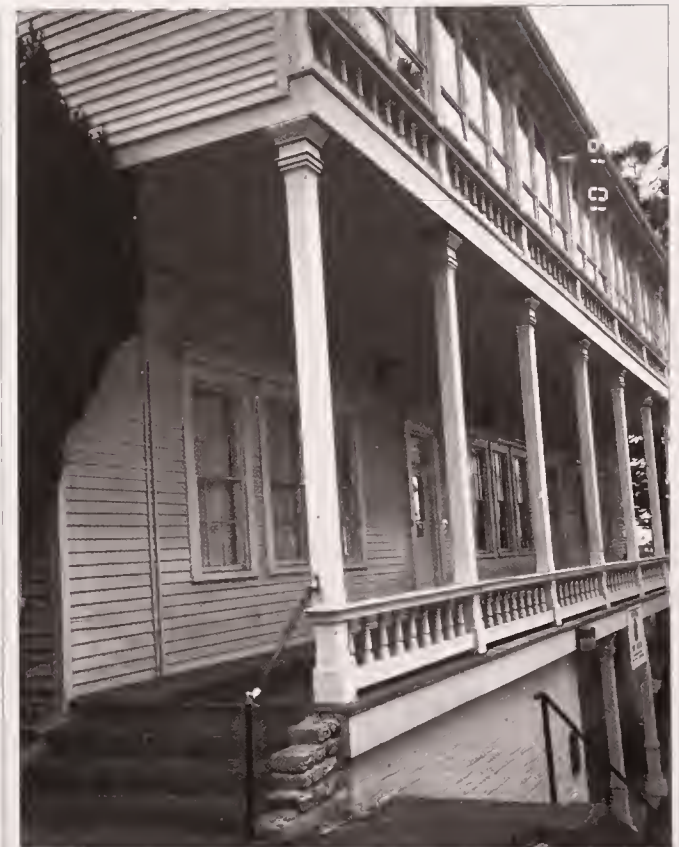
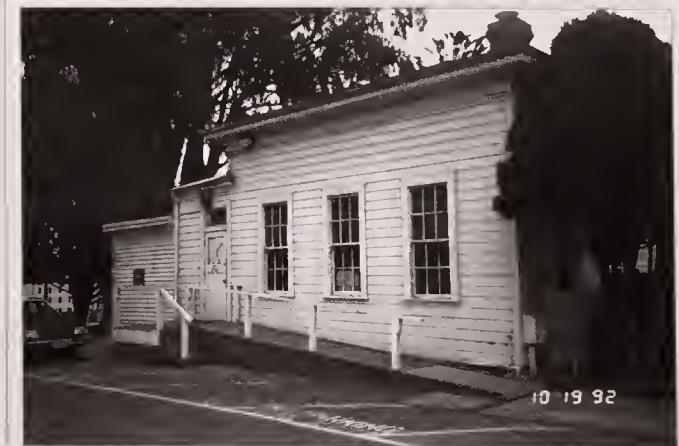
*This important public building, (top right) is currently only partially accessible through a rear office entrance, (shown lower right). By regrading the site from the front porch to an accessible parking area, replacing the nonhistoric front steps (shown above), with a ramp of 5% or less slope, and sensitively modifying the low porch railing, the disabled could more easily reach the building’s public spaces.*

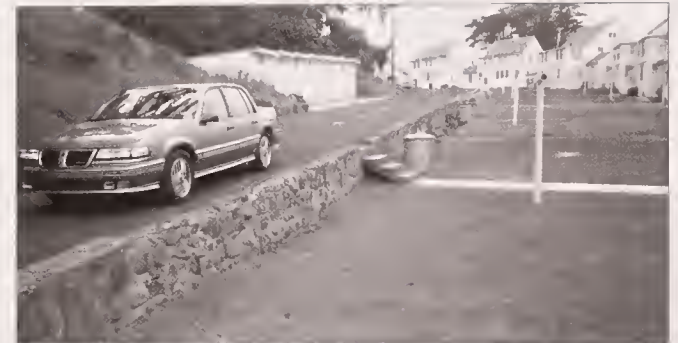
*Access from these residences to the street and to garages is prevented by the change in grade. Regrading the lower-level lawn and adding a sloped walk or ramp would destroy the historic grading of the site and circulation features. Other less destructive solutions should be sought.*

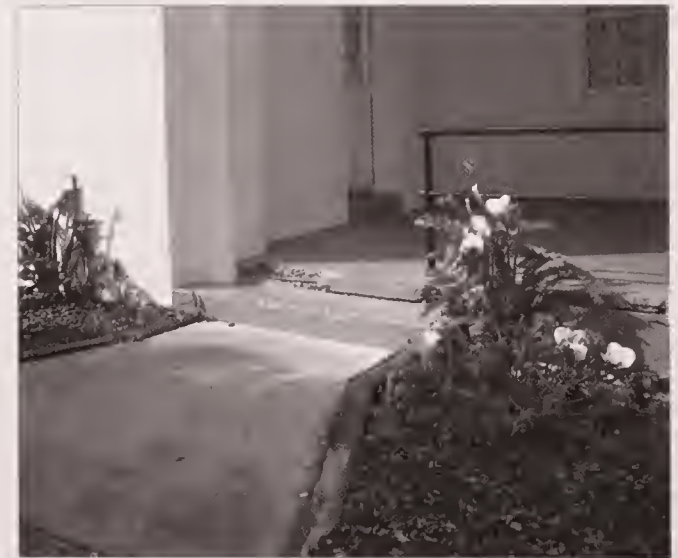
*A common condition at the Presidio—the one- or two-step elevation of the first floor above grade level, as shown here—could in some cases be treated by regrading and constructing a sloped sidewalk, which is preferred to a ramp because of its reduced effect on the historic appearance of the building.*

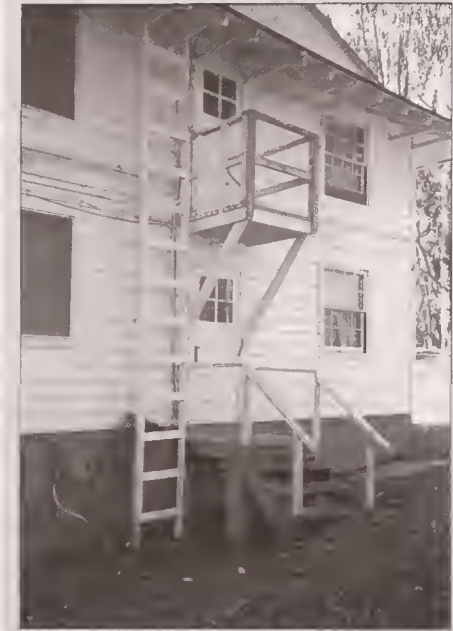
*Some Presidio buildings were built as temporary structures. These may have significant code deficiencies, including noncompliant fire exits.*

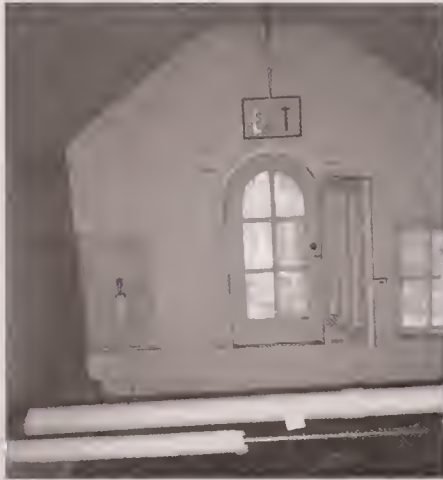
*Several safety issues are illustrated above—pipe insulation may contain asbestos, pipes block access to the fire exit, and the exit is noncompliant.*

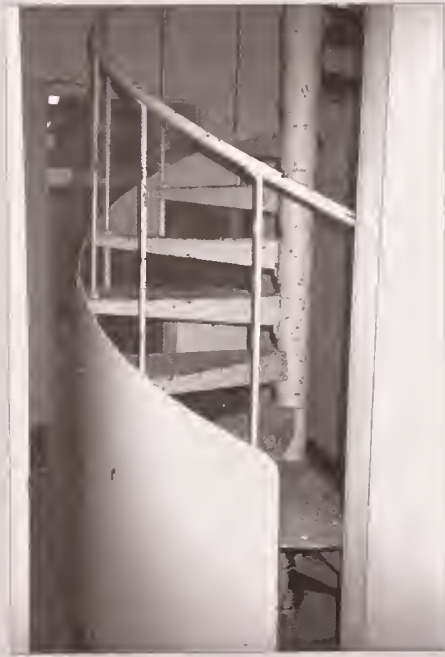
*Each building has its own particular health and safety issues. A spiral staircase, for example, is not an acceptable exit.*

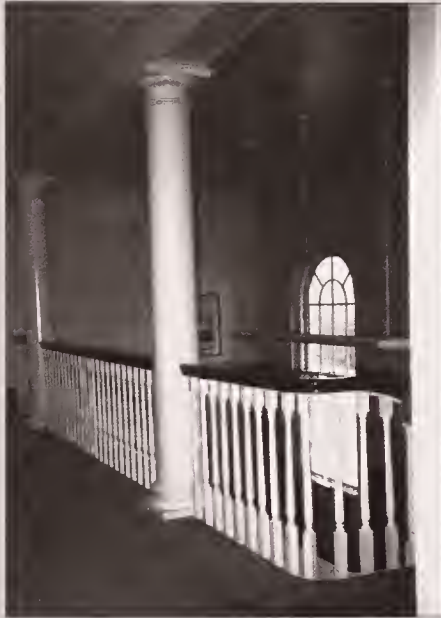
*Open stairways that do not separate the exit route from other areas of a building create common compliance problems at the Presidio. Stairways may also be considered deficient based on their riser-to-tread ratio, railing height, winders, or nonfireproof materials. Actual risk should be determined using the SHBC. Consider alternative means to meet fire and life safety codes, such as constructing new stairs at another location.*

Use the SHBC to determine the real risk where the stair riser-to-tread ratio is deficient, resulting in stairs that are too steep, or where stairs include winders. Consider alternative methods of code compliance if necessary, such as constructing new stairs at another location.

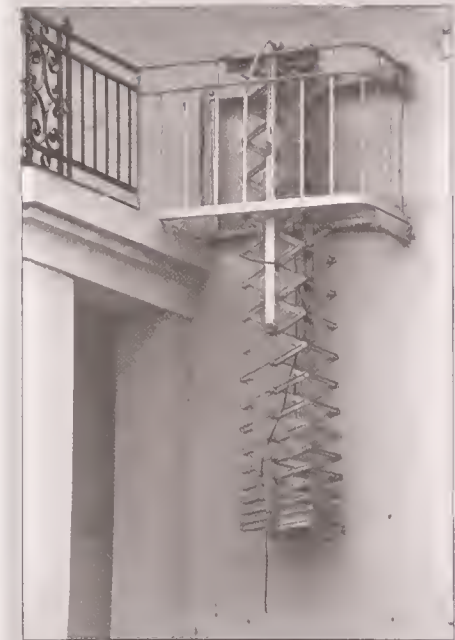
*Exterior-mounted metal or wooden fire escapes are often the second means of egress from multistory Presidio buildings. Previously approved fire escapes that are structurally safe may be acceptable as one of the required means of egress in some occupancies under the SHBC. If they are intrusive elements on a primary facade, consider replacing them with more appropriate means of egress, such as interior stairs in nonsignificant service spaces.*

Remove intrusive elements, such as fire escapes on primary facades, and replace them with more appropriate means of egress.

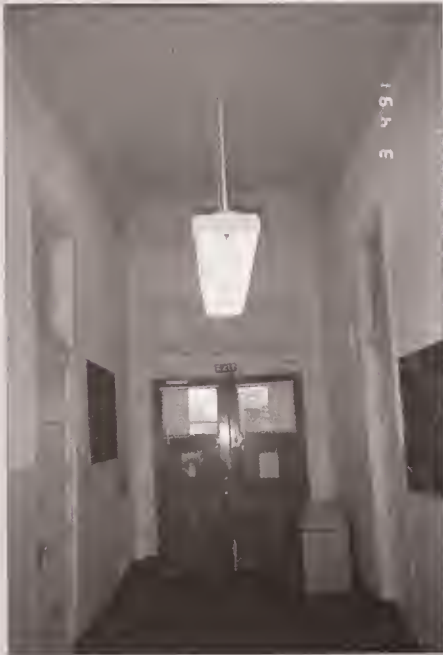
*A number of buildings at the Presidio have double-loaded corridors with transom windows. These can be modified to increase their fire-resisting capacity by replacing plain glass with approved or listed wire glass, or liquid-filled double-pane lights (visually preferable); or, if necessary, by adding a fireproof panel on the less significant or less visible side of the transom frame.*

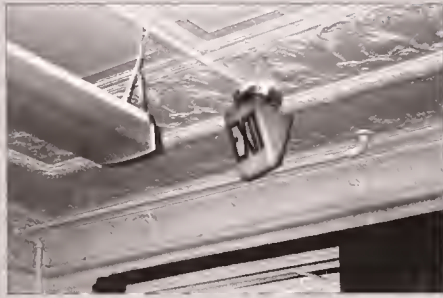
*Mounting the exit sign shown above required drilling holes through a historic pressed metal ceiling. Exit signage should clearly delineate the exit path, but the choice and placement of components should not damage historic finishes.*

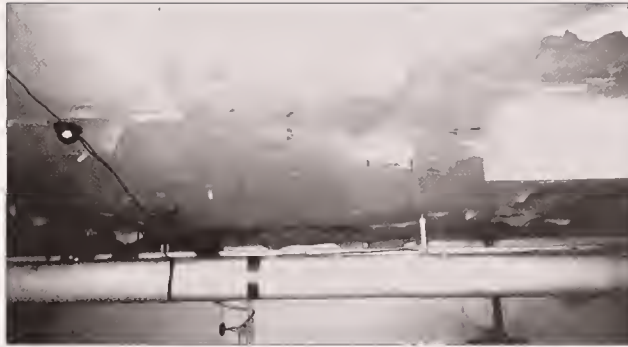
*Both lead-containing paint and asbestos-containing insulation are problems in many Presidio buildings. Their location and condition will determine the appropriate treatment.*

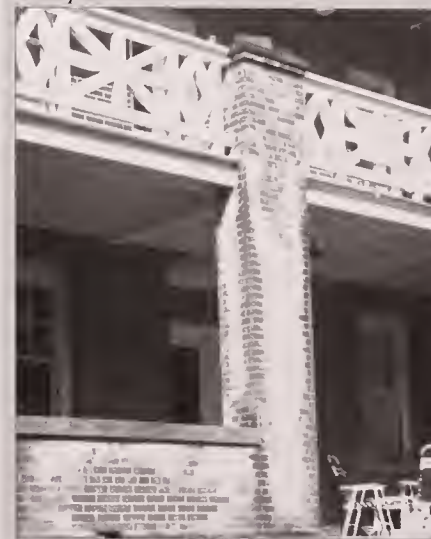
*Pier*

**Pier** - a masonry structural support, more massive than a column, for an arch, lintel, or beam; often an element of a foundation system; see illustration

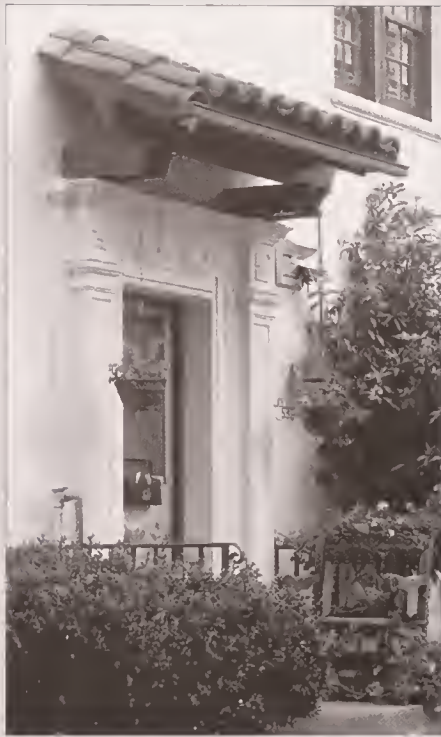
*Pilaster*

**Pilaster** - a shallow rectangular column or pier attached to a wall, often modeled on a classical order; frequently found flanking doors or windows; see illustration
